Assessment of Dam Safety

Coal Combustion Surface Impoundments (Task 3)

PacifiCorp

Naughton Power Station

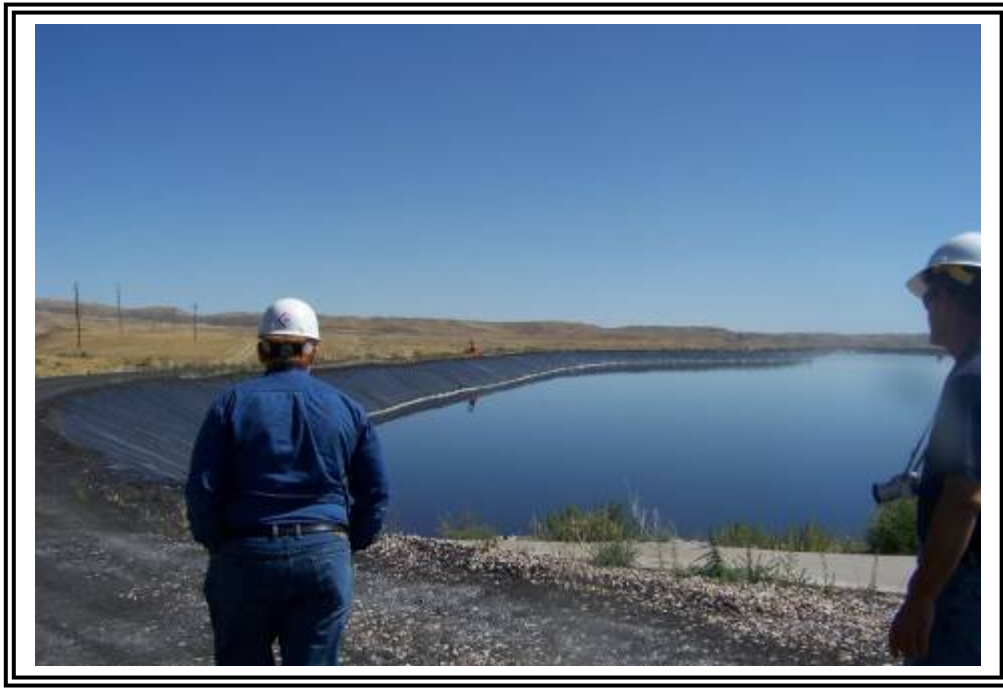
1

The upstream slope is covered with a 30 mil PVC liner as shown in Photos 1, and 18. A couple of depressions were noted on the upstream slope/crest intersection at the north end of the northeast dike as shown in Photo 3. PacifiCorp representatives indicated this was an area where sluice lines had formerly been laid, and that some frost heaving issues had occurred. The access road on the crest was re-graded, but the resulting depressions at the top of the upstream slope were not repaired.

Upstream slope of northeast dike looking east.

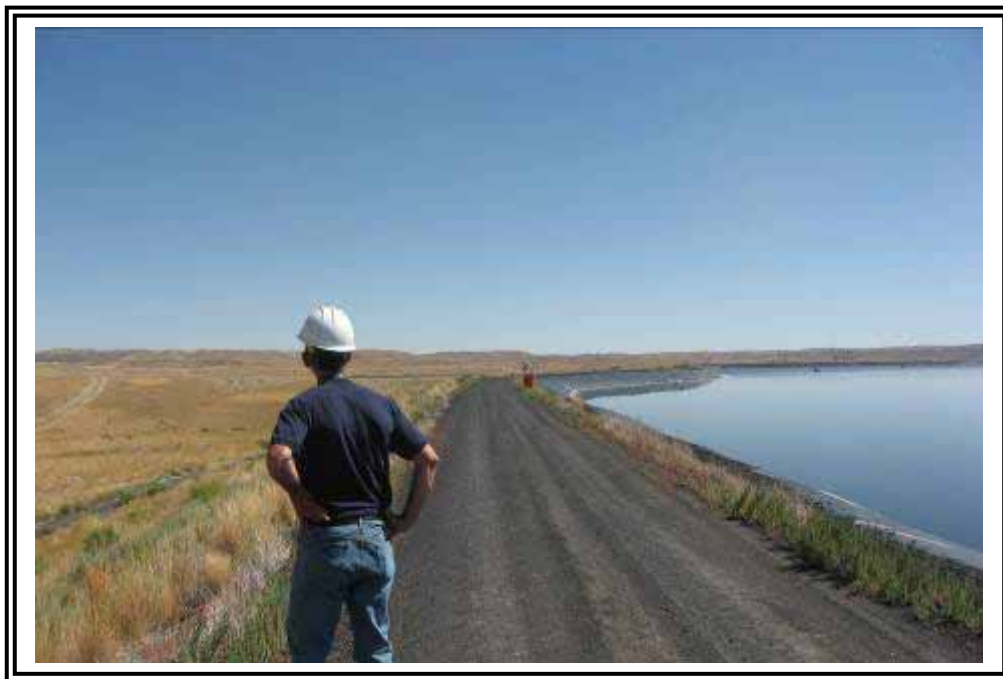
2

In general the alignment of the encircling dike crest appears to match the design drawings reviewed for this project. There is an access road that runs the entire length of the dike crest. In some areas, re-grading of this access road has led to over steepening of the top of the downstream slope as shown in Photo 4. Photos 2, 15, 20, and 25 show the general conditions of the crest around the FGD #1 Pond.

Crest of northeast dike looking southeast.

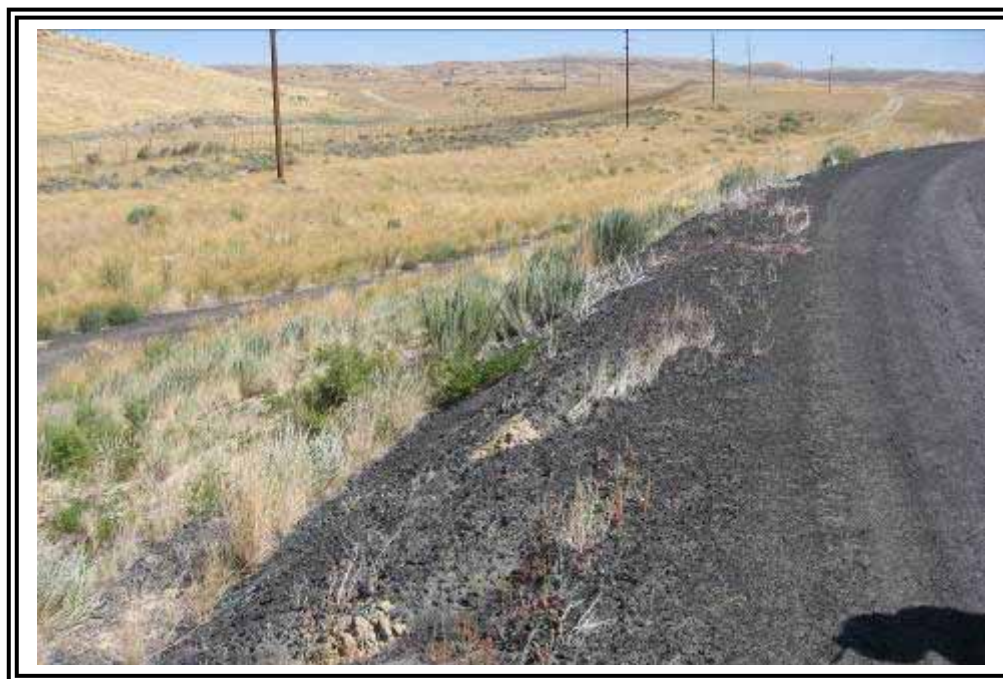
4

Over steepening of downstream slope at crest of northeast dike from across road grading.

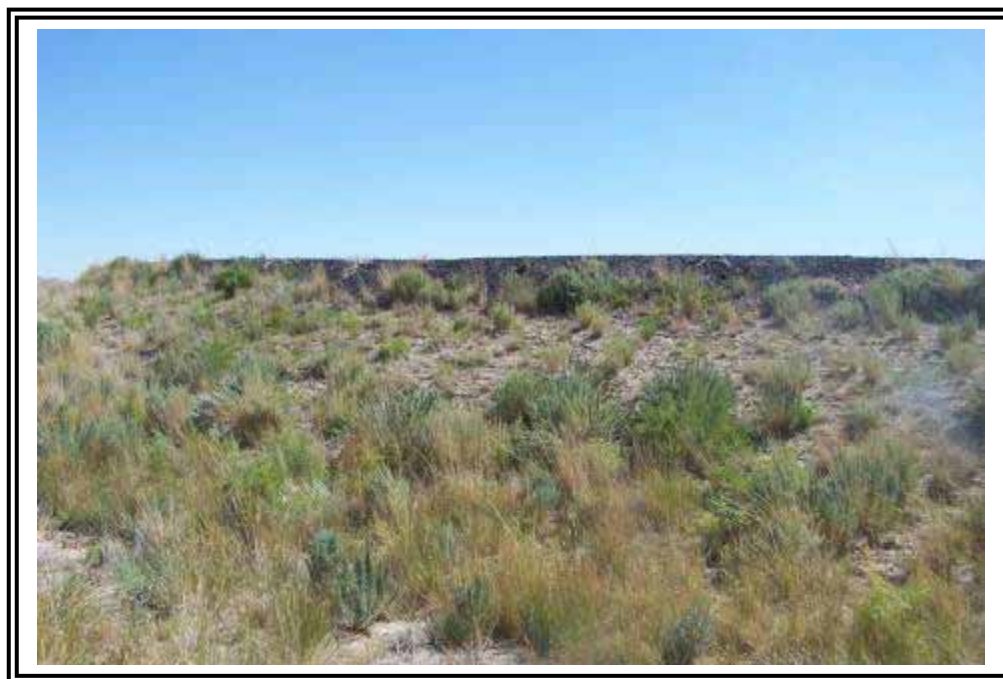
6

The downstream slope is vegetated primarily with crested wheatgrass. Photos 6, 8, 17, and 29 show the general conditions of the vegetation. As these photos show, the vegetation is very sparse in some areas, with apparent growth hampered by prevailing direction the slopes face. Occasional erosion rills were noted, such as that shown in Photo 5. A series of animal burrows were observed near the north end of the northeast dike as shown in Photo 9. In general the slopes appear fairly uniform, and did not exhibit signs of movement.

Typical vegetation cover on north end of FGD #1 Pond downstream slopes.

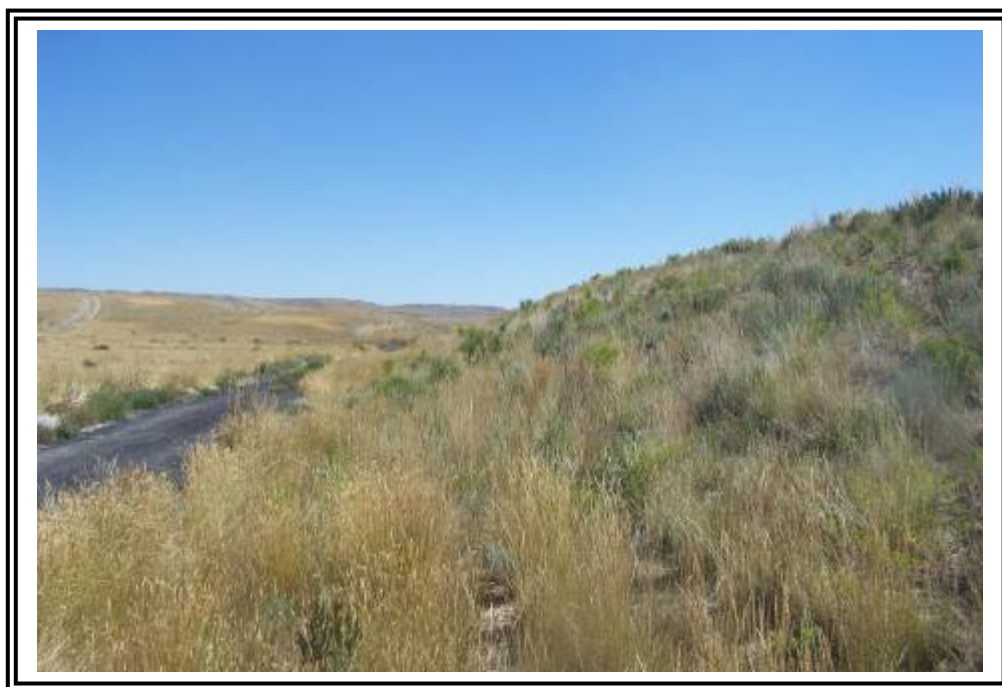
7

Downstream slope at north end of northeast dike.

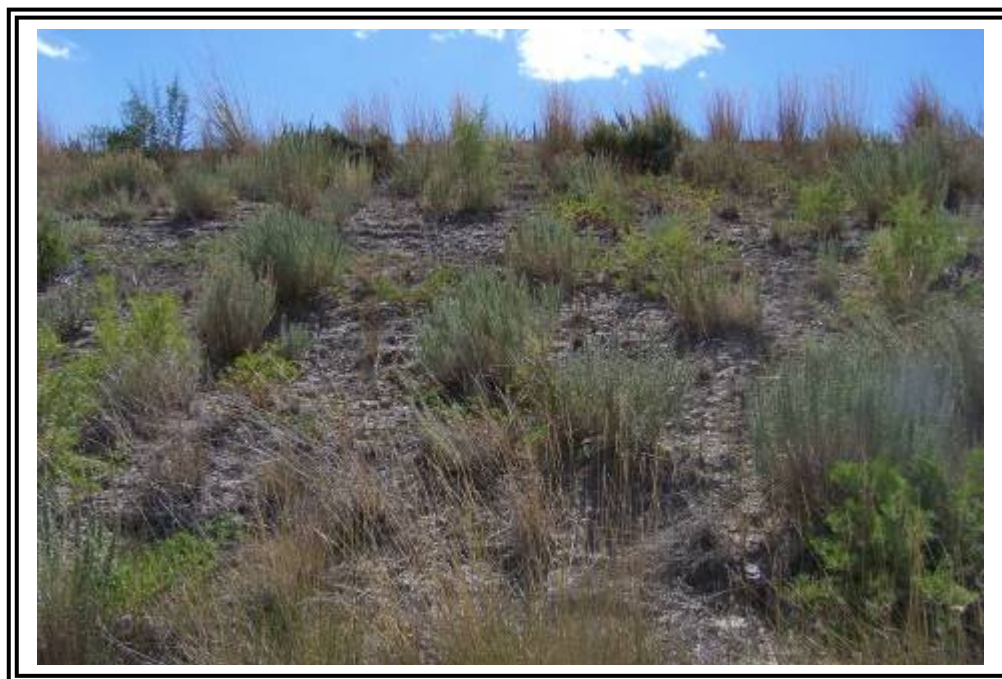
8

Sparse vegetation cover on northeast dike downstream slope.

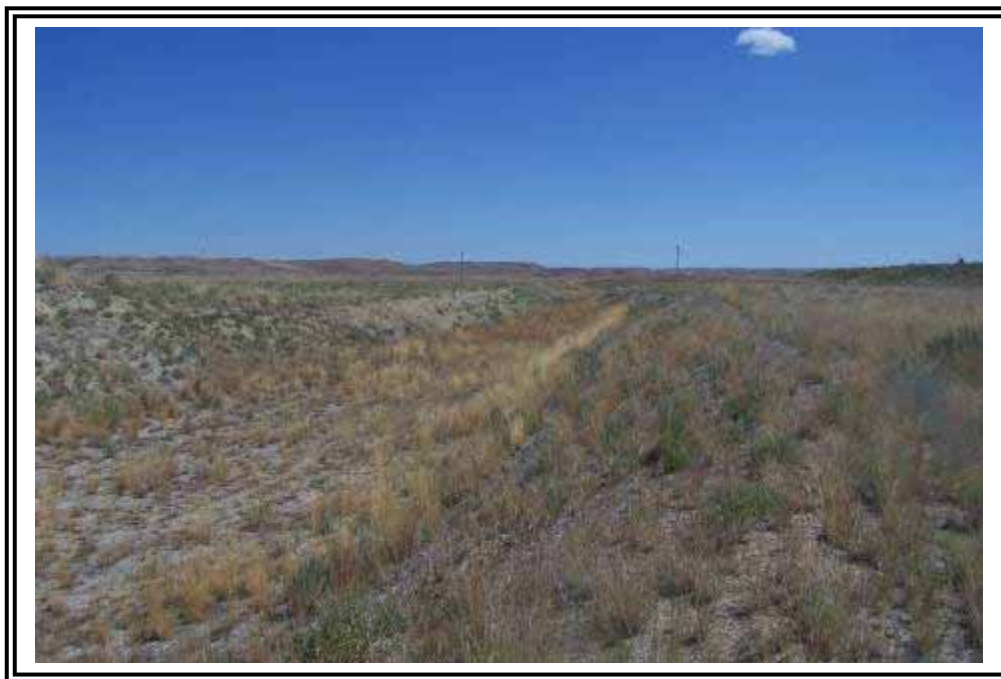
12

Diversion channel along northeast side of FGD #1 Pond toe.

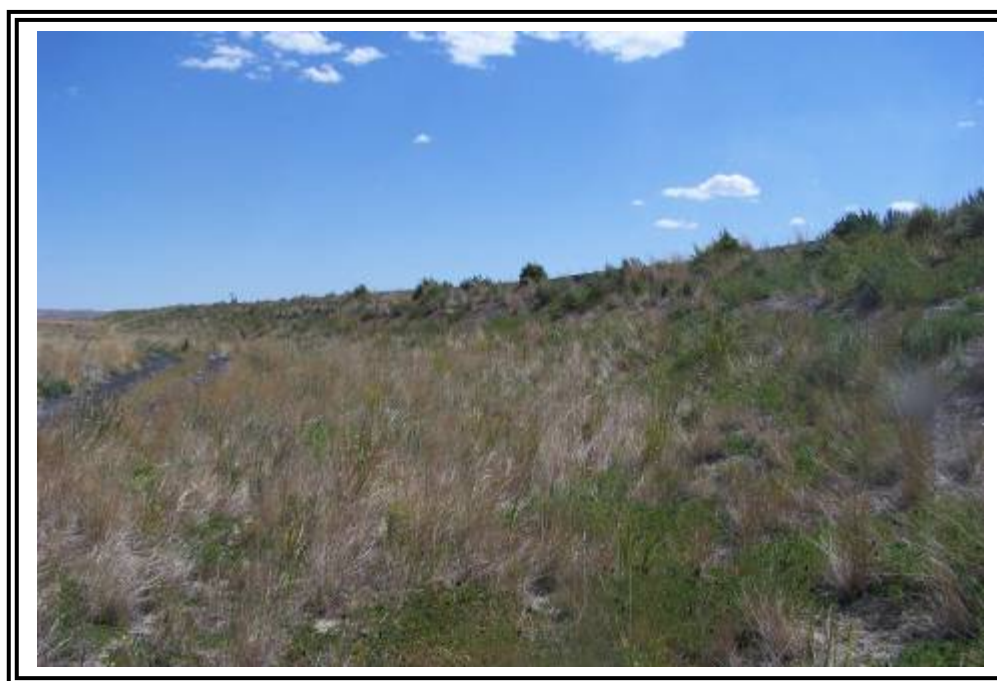
14

Toe of mid section of northeast dike.

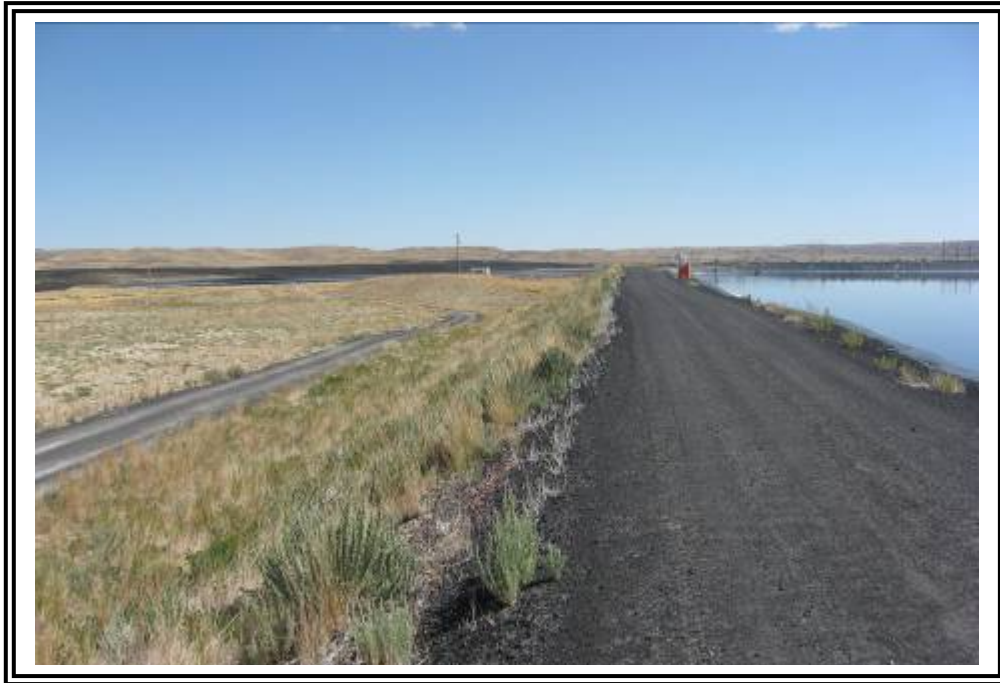
15

Crest of south end of northeast dike.

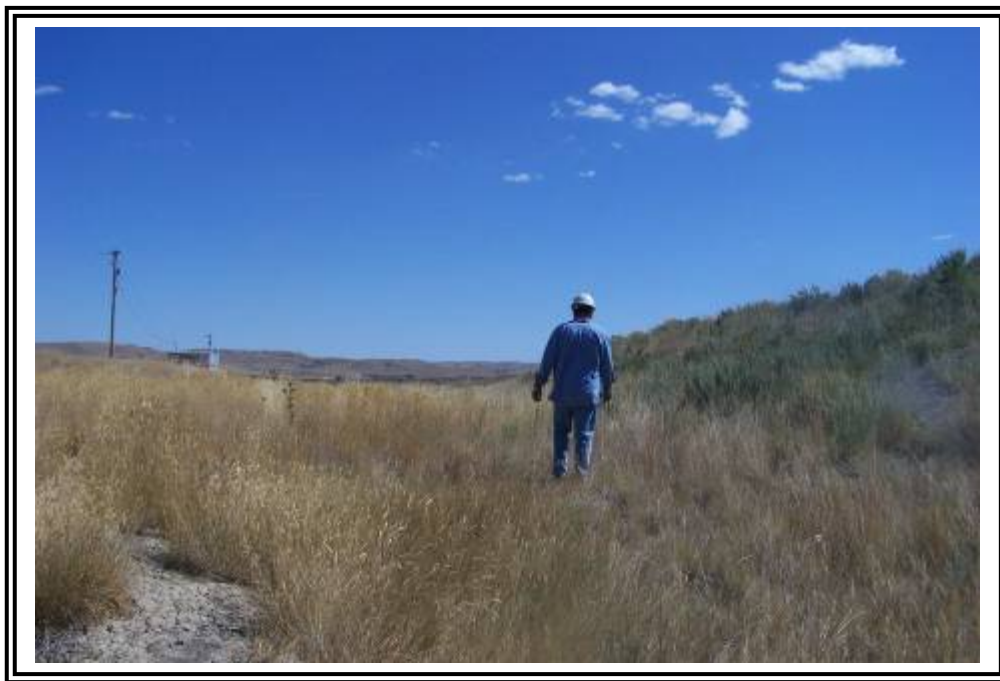
16

Toe of south end of northeast dike.

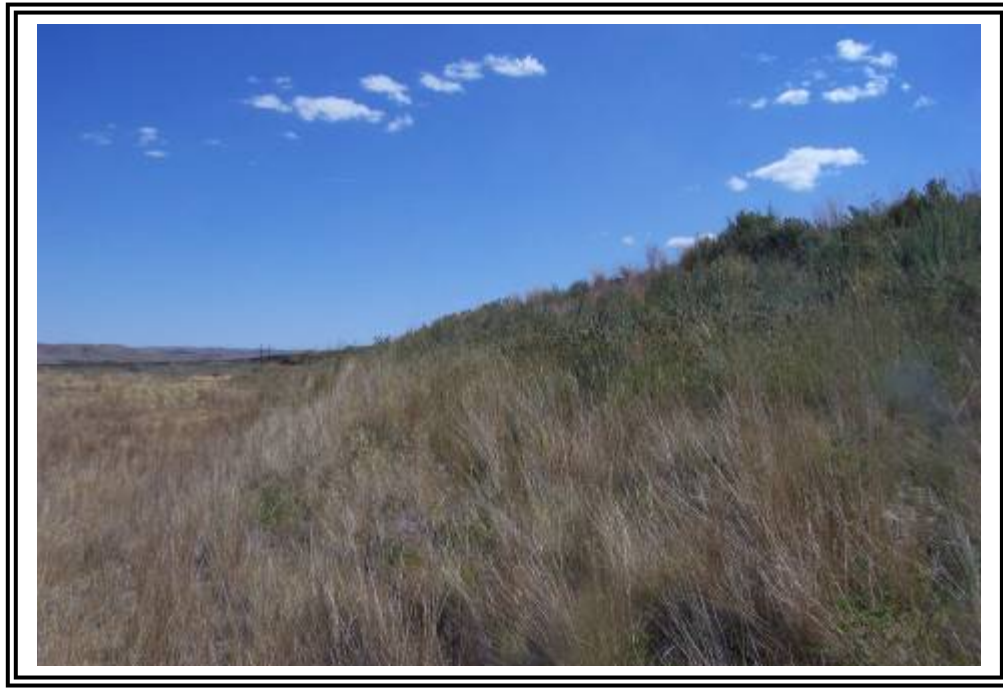
17

Typical vegetation at south end of northeast dike.

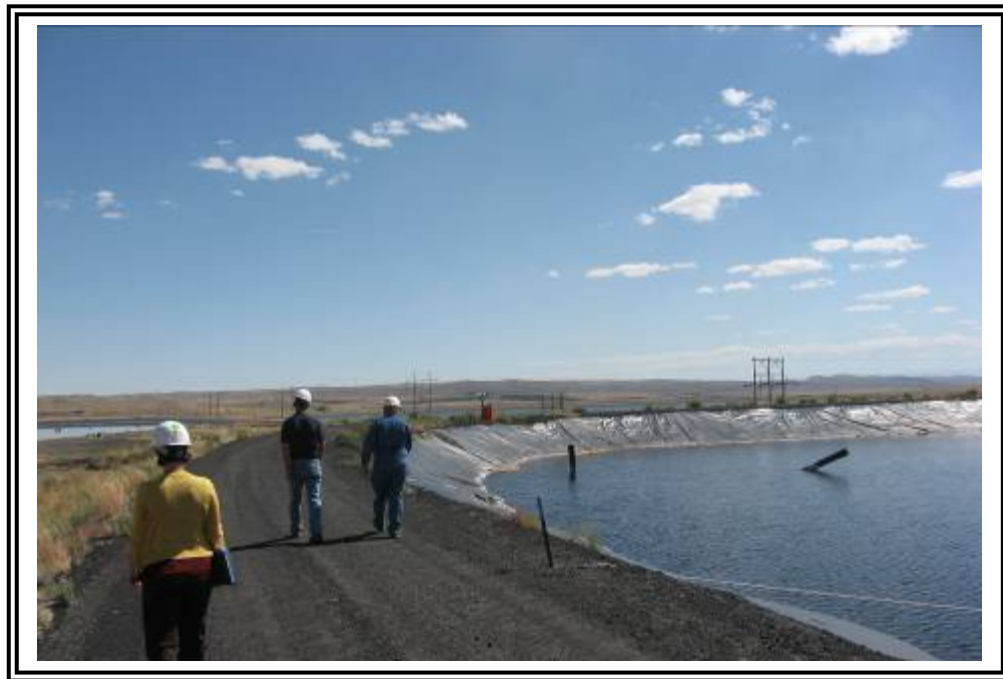
18

Upstream slope of southeast dike looking south.

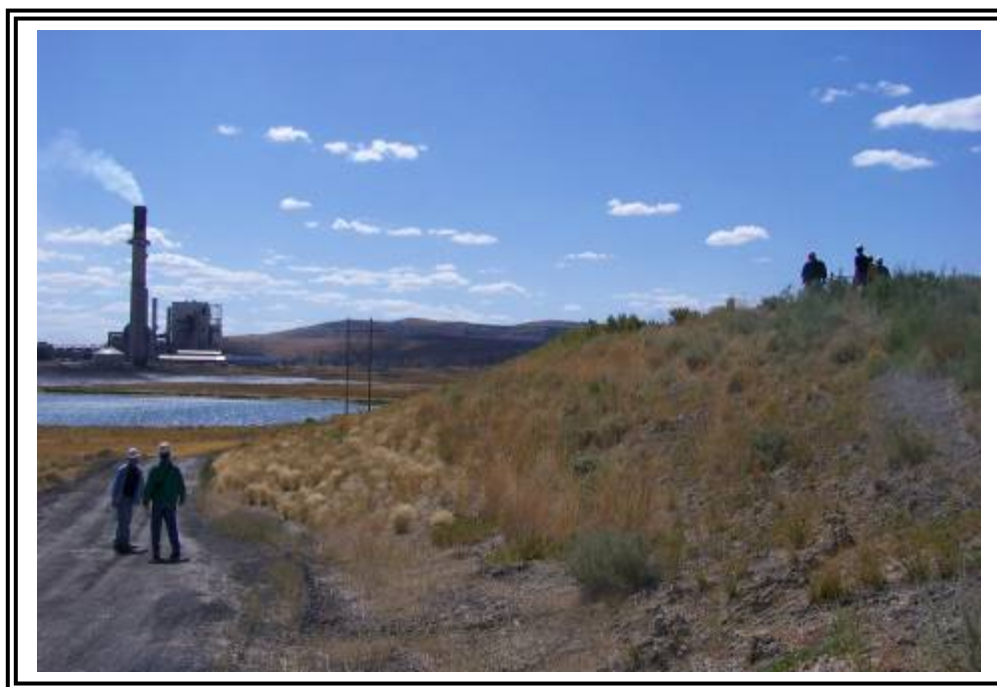
19

Downstream slope of southeast dike.

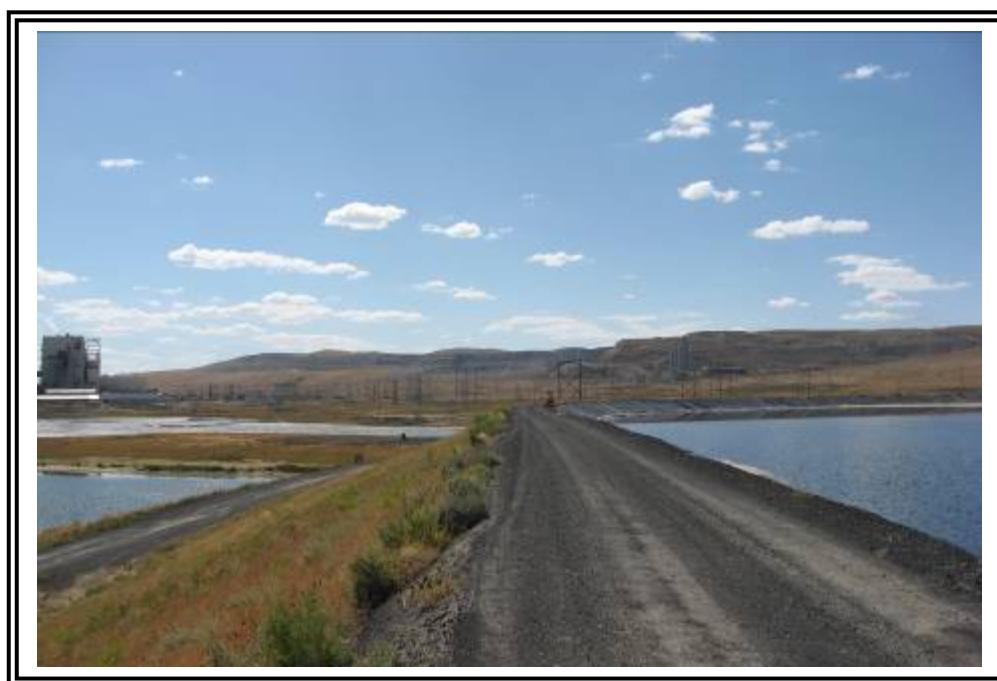
20

Crest of southeast dike.

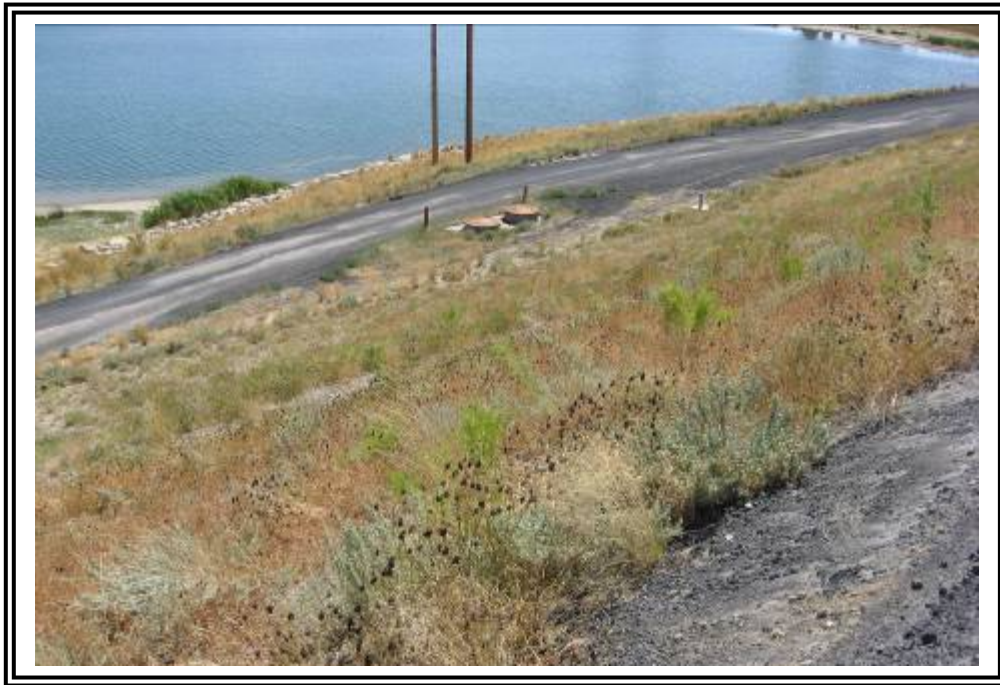
21

Valve at toe of southeast dike (contains cleanouts to sluice line to FGD #2 Pond.)

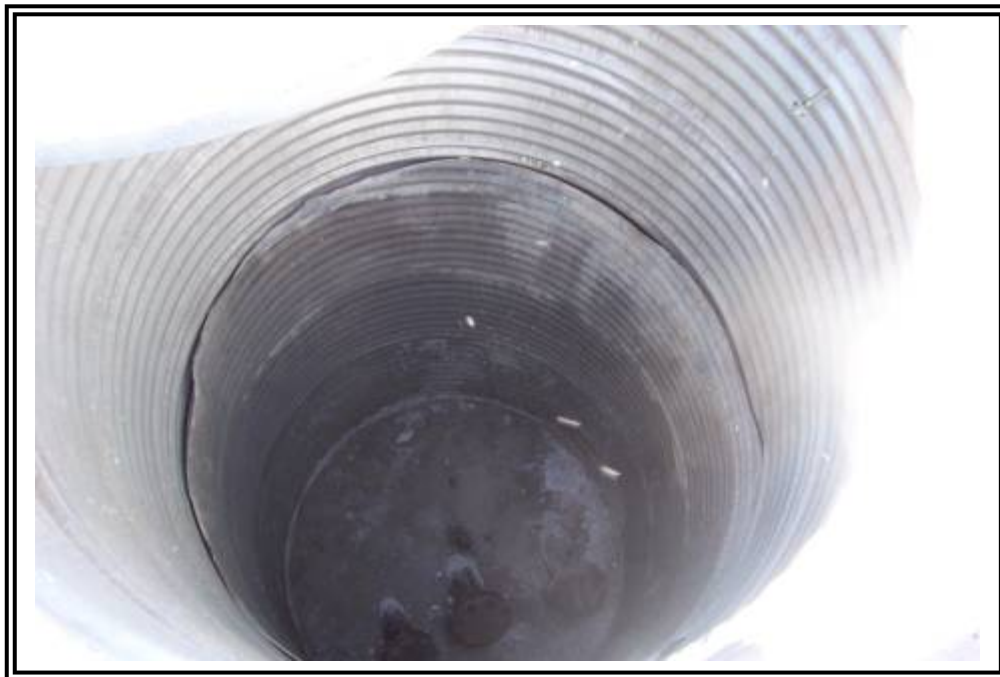
22

Valves in vault at toe of southeast dike about 13 feet deep (cleanouts to sluice line to FGD #2 Pond.)

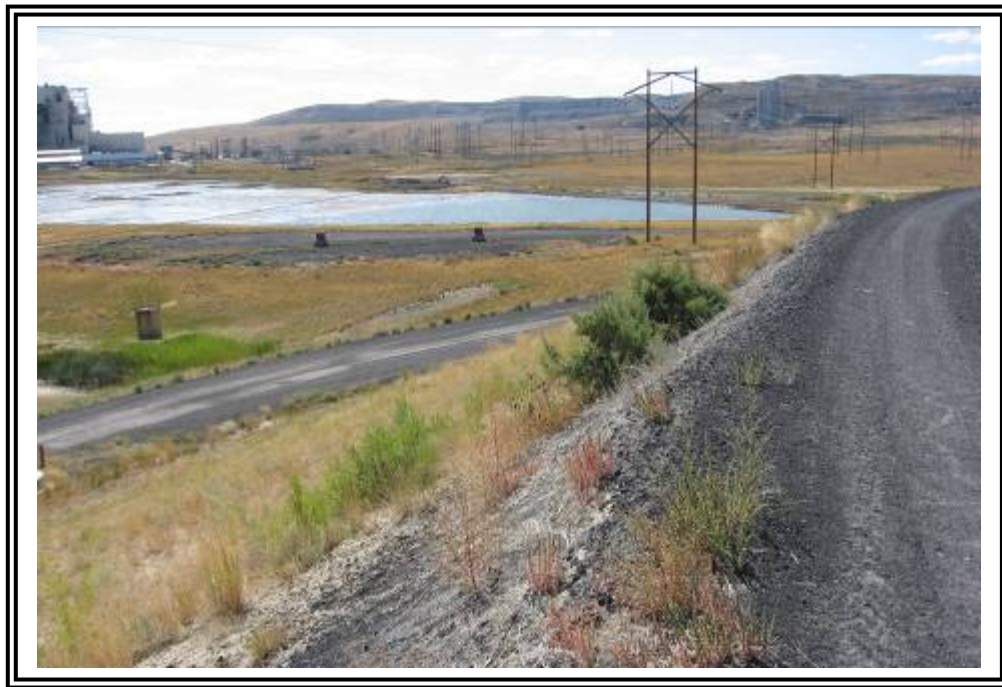
23

Upstream slope south end of southeast dike.

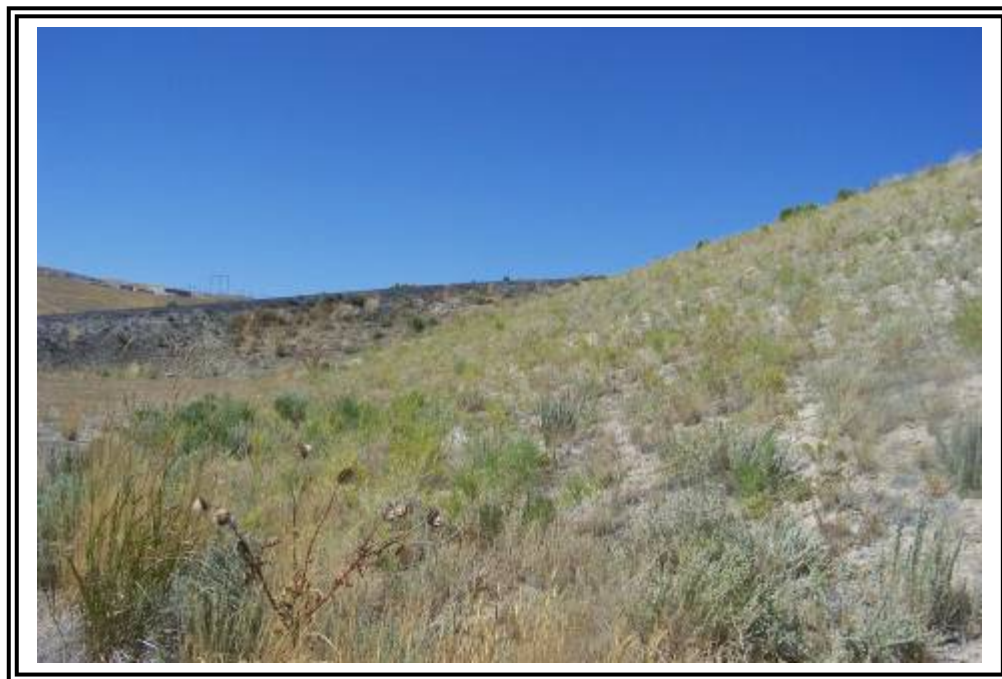
24

Downstream slope at south corner and ramp for access road to crest.

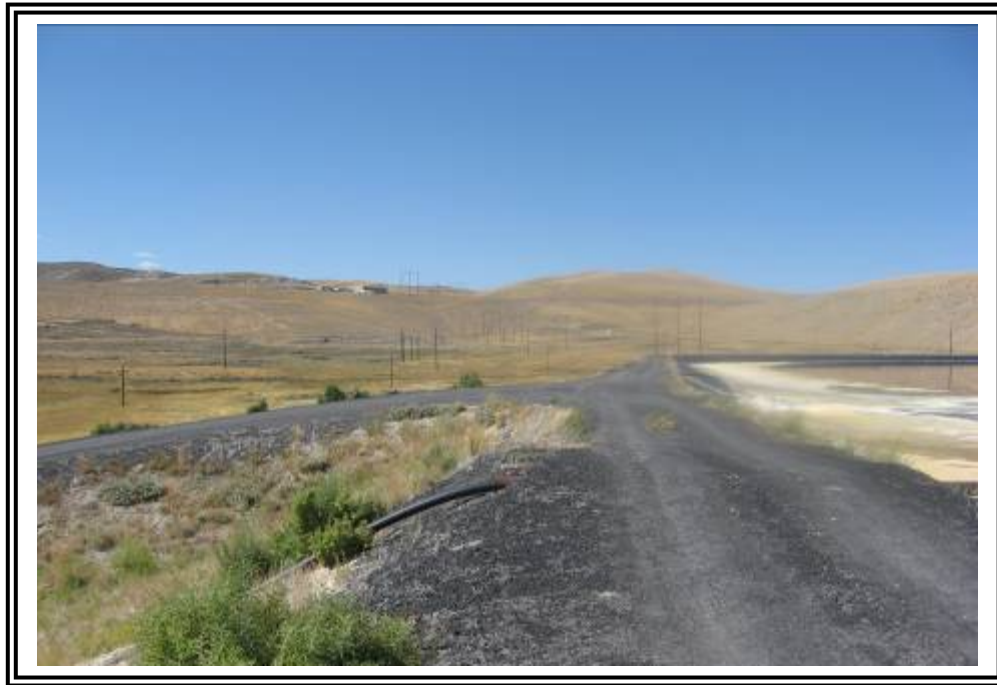
25

Crest of southwest dike looking northwest. Sluice line in foreground.

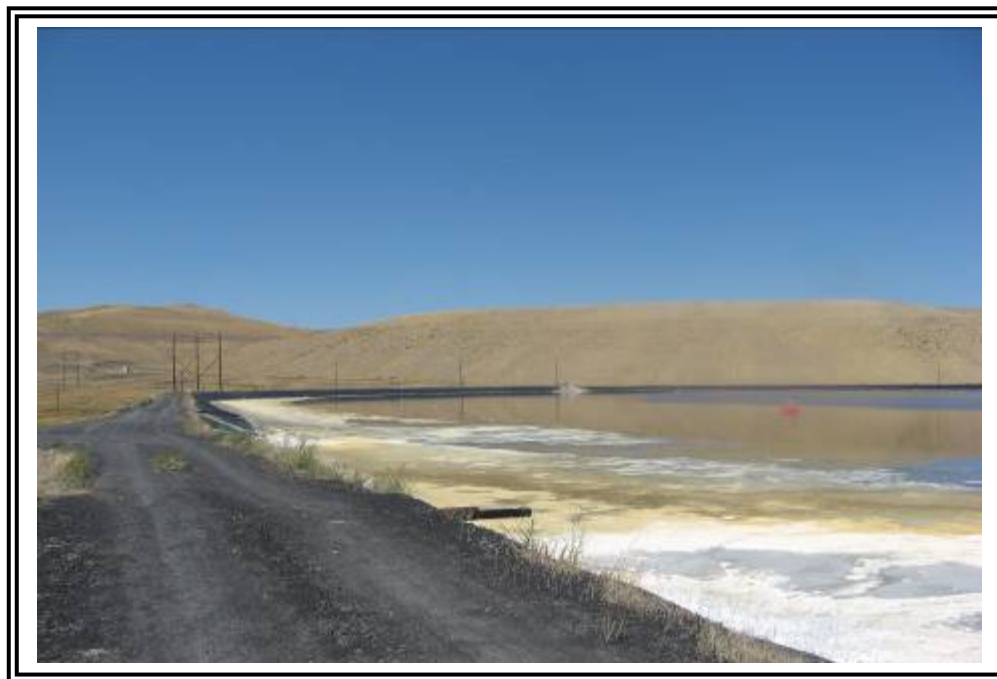
26

Sluice discharge area along southwest dike.

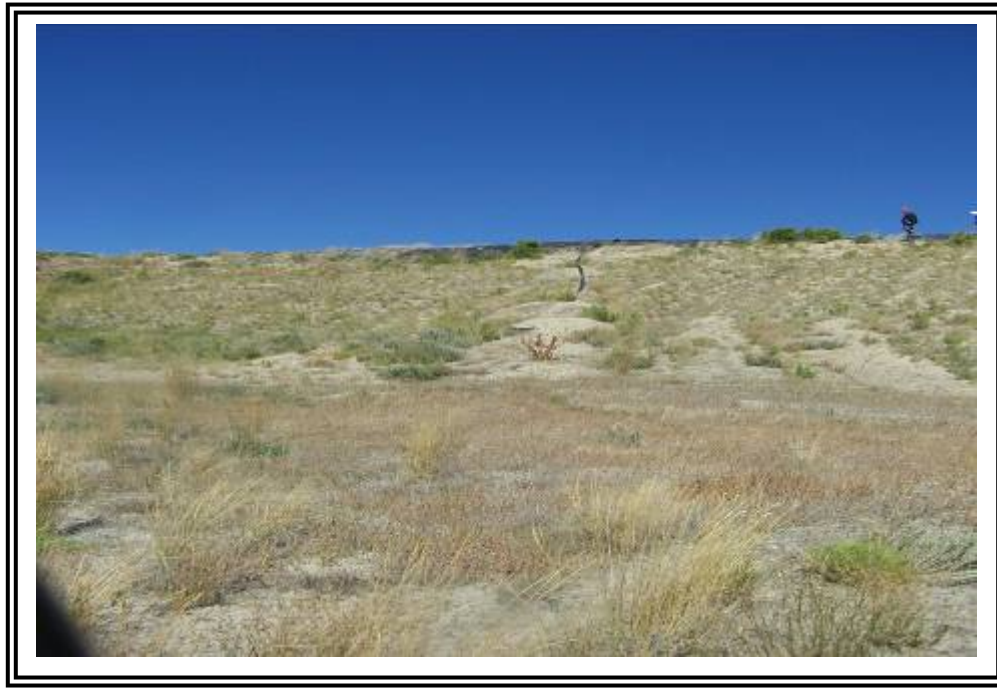
27

Sluice line at ground surface up downstream slope of southeast dike. Soil piles “anchor” HDPE pipe.

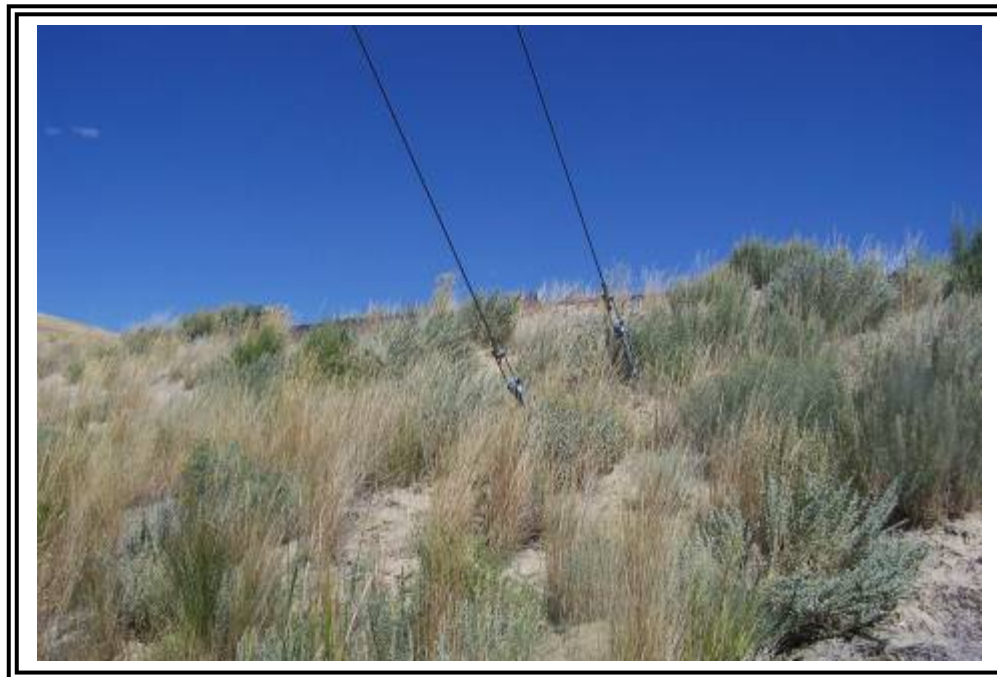
28

Guy wires from adjacent power poles at west dike downstream slope.

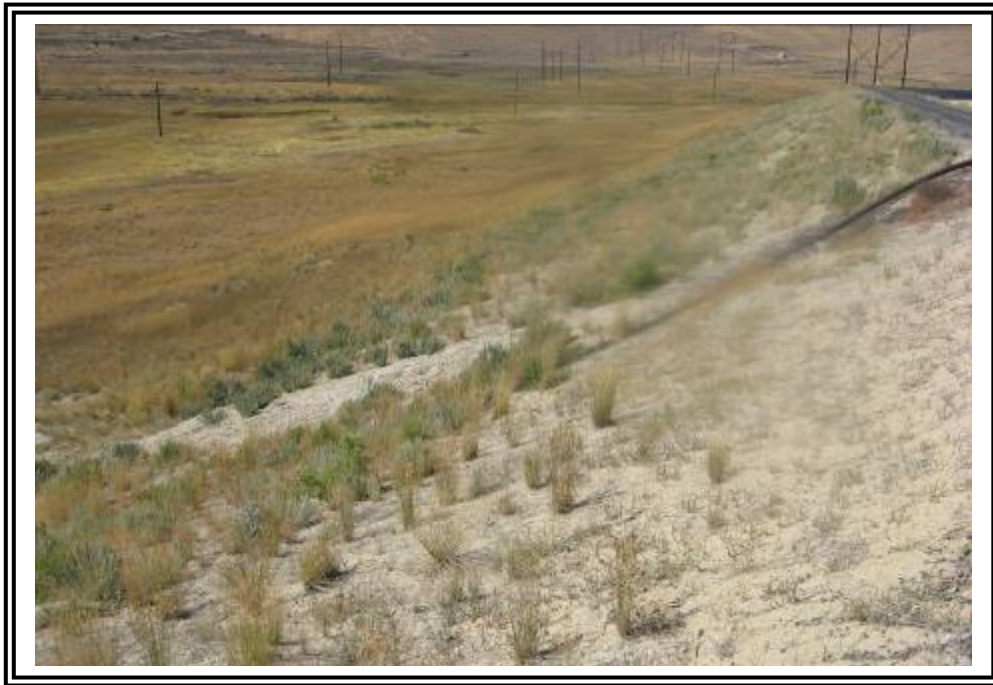
29

Sludge line and sparse vegetation mid section of southeast dike.

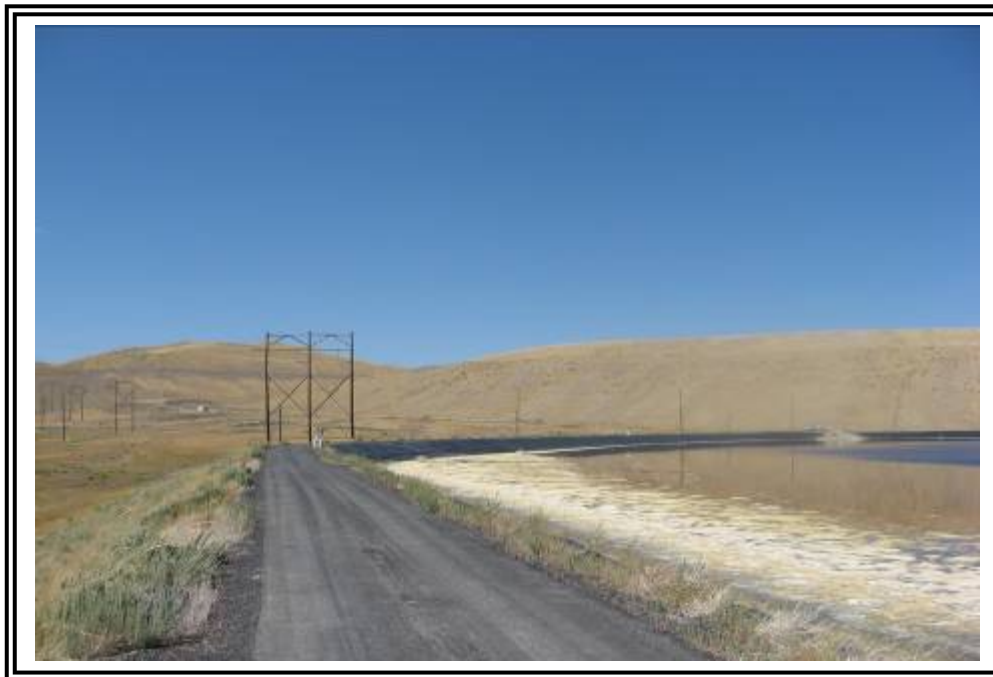
30

Crest north end of southwest dike.

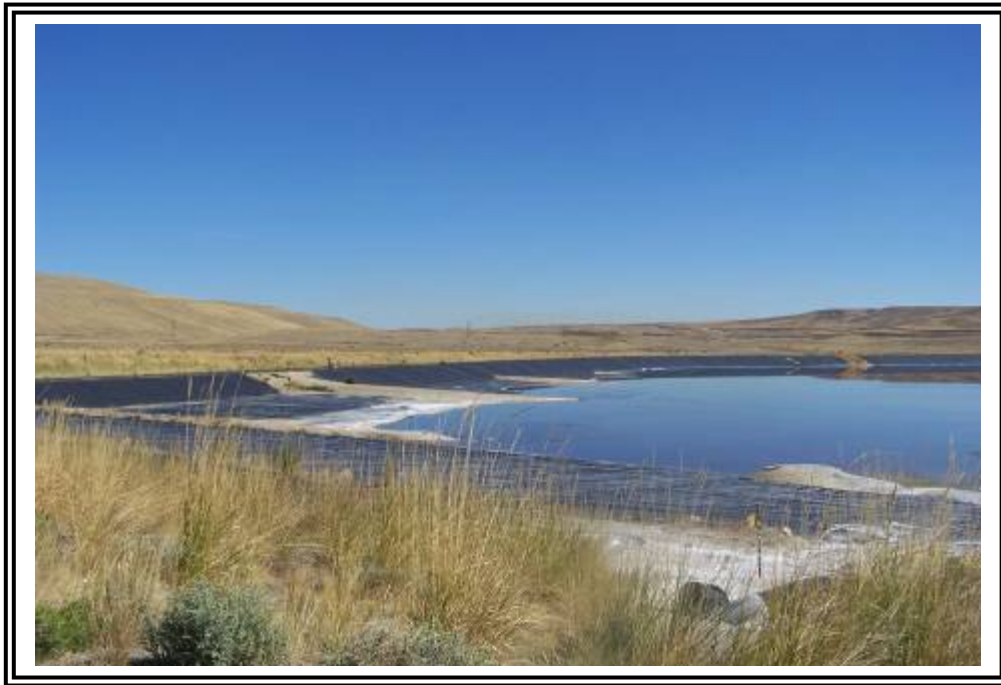
31

Northwest end of FGD #2 Pond incised into original ground.

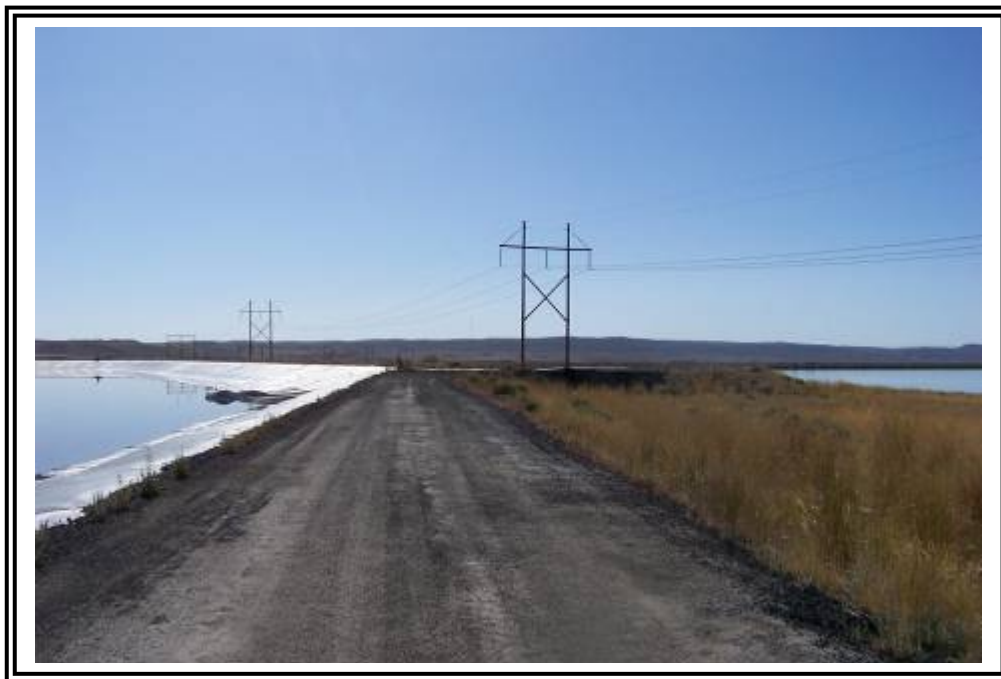
32

Southwest access road along FGD #2 Pond. Dike begins around closet Power Pole.

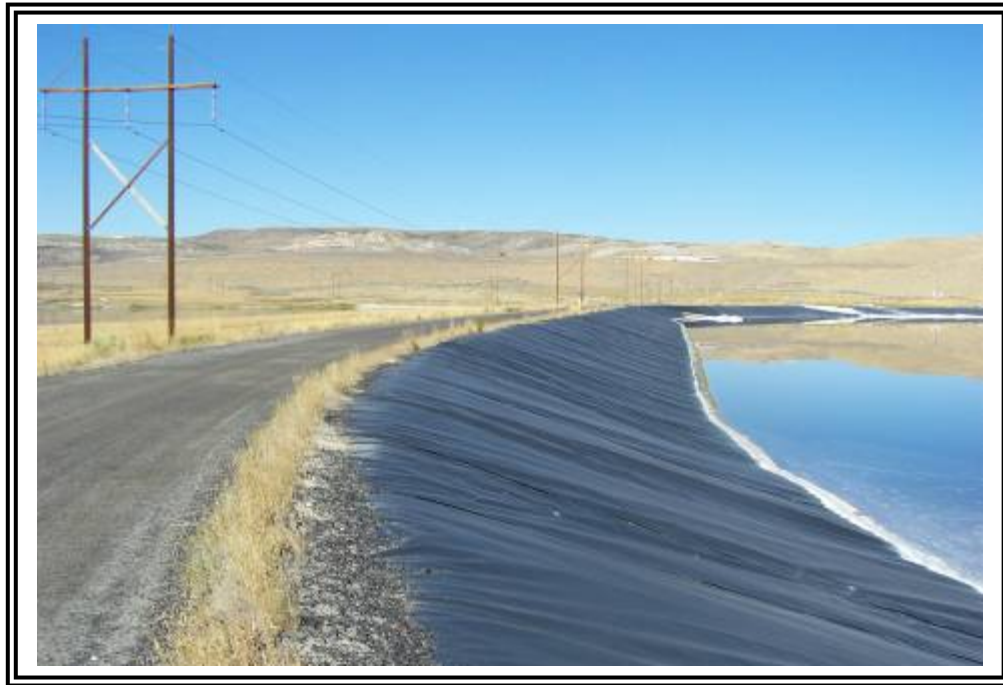
33

Upstream slope south dike looking northwest.

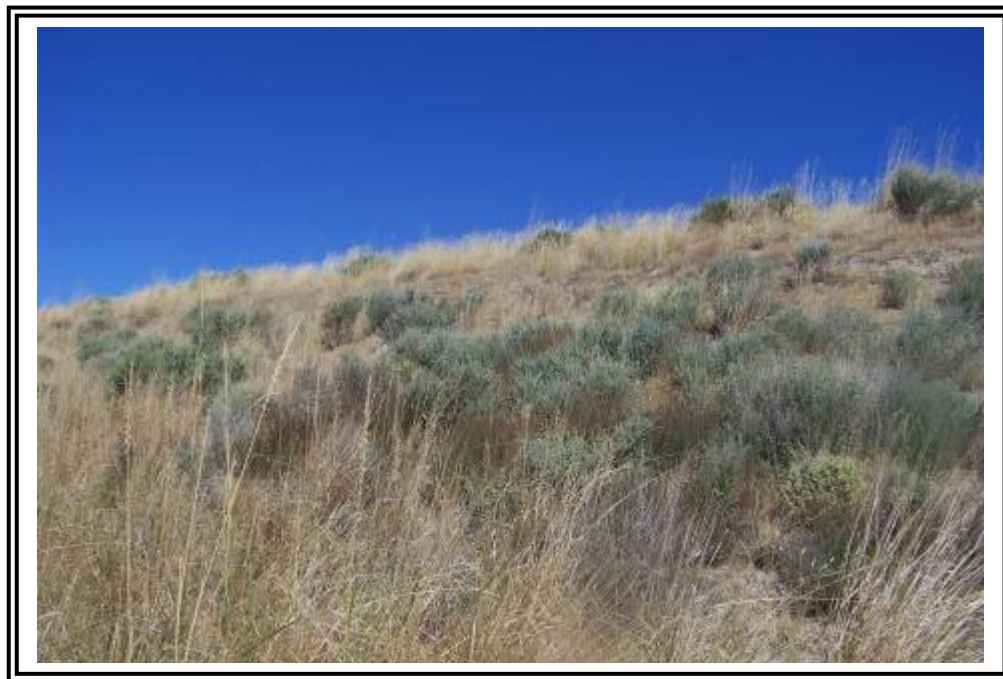
34

Downstream slope of south dike. Typical vegetation.

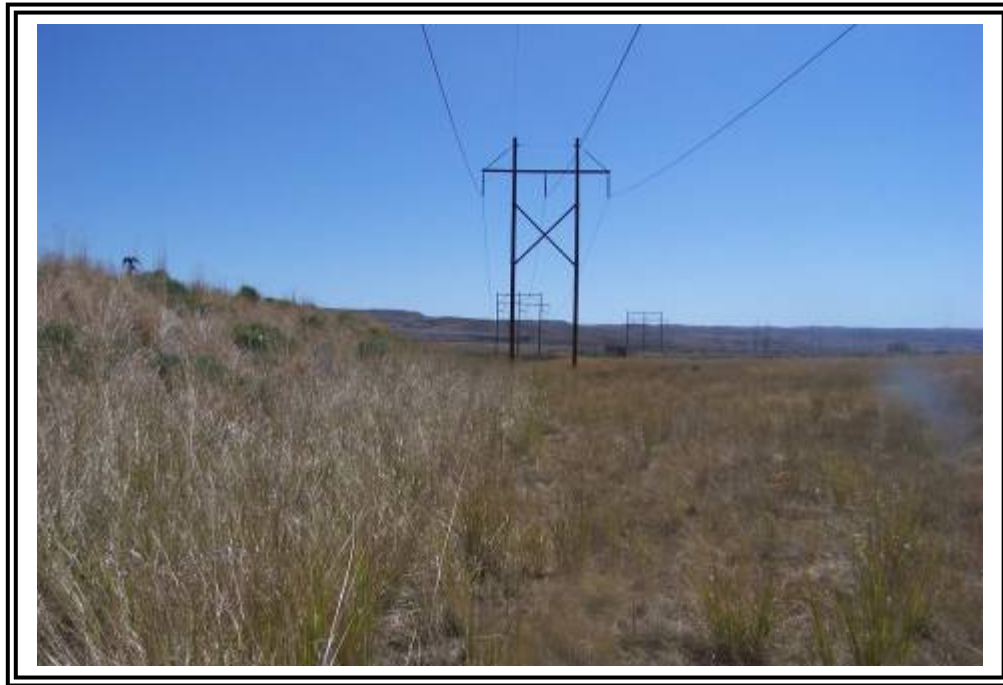
35

Downstream slope looking southeast along south dike.

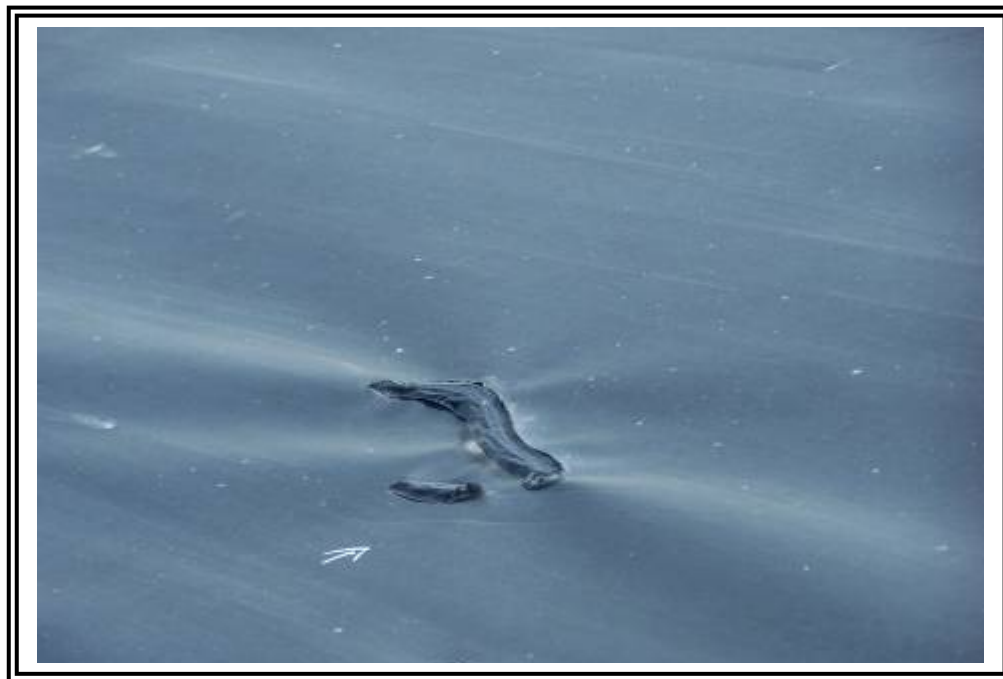
36

Patch on liner. Routine inspections/maintenance performed to correct holes generated by wildlife.

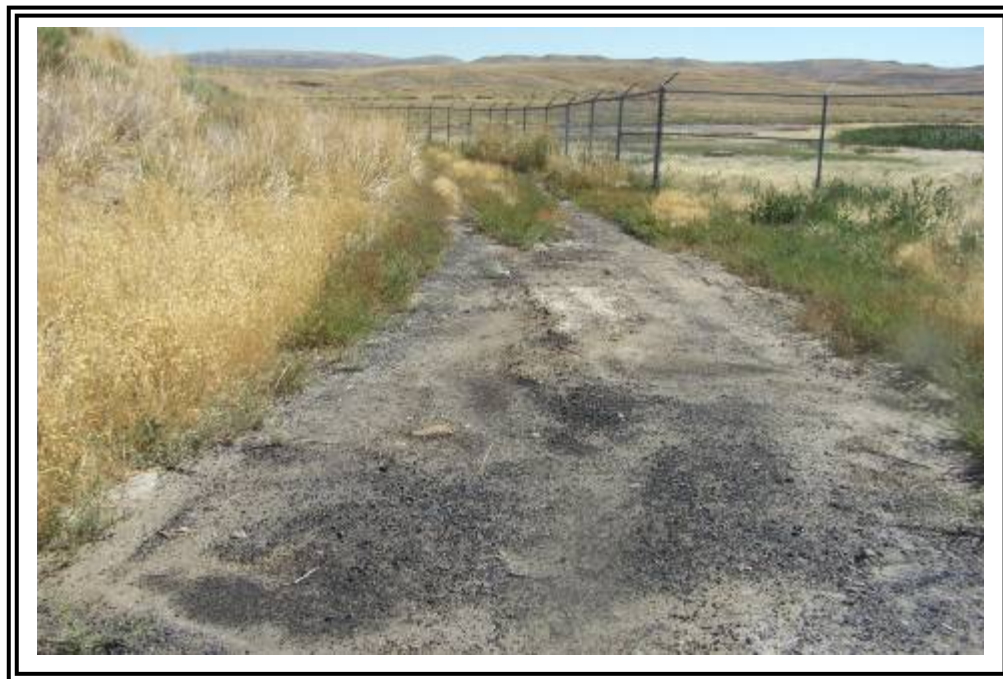
38

Access road at downstream toe at south corner looking east.

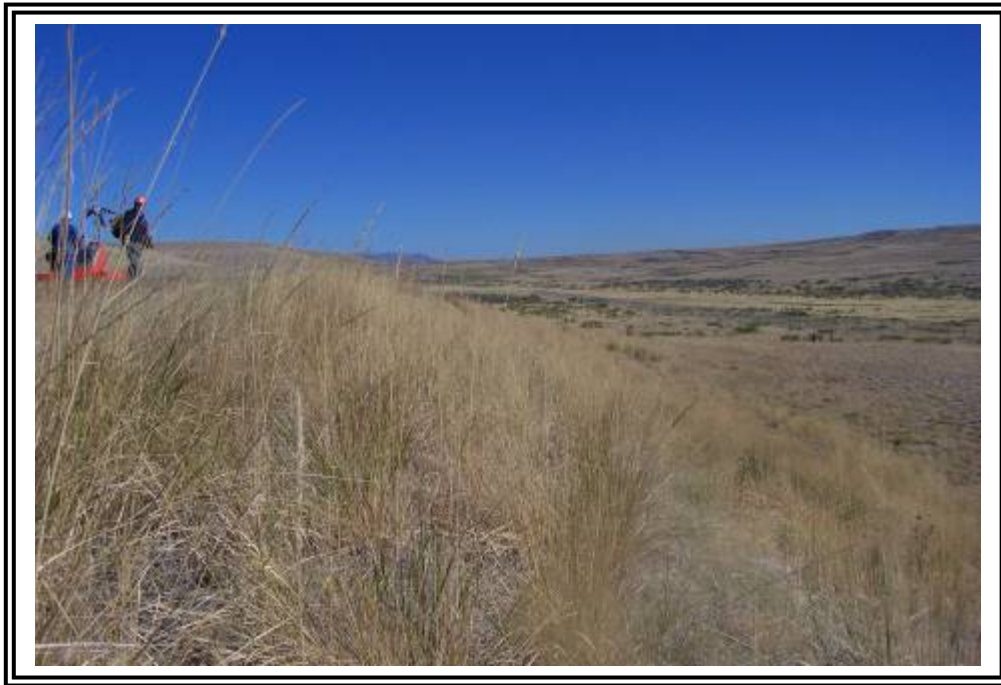
39

Downstream slope looking northeast at south corner.
